Preliminary Biodiversity Assessment of the Algonquin Gas Pipeline in the Towns of Yorktown and Cortlandt, Westchester County, New York

Erik Kiviat PhD
Hudsonia

Report to Community Watersheds Clean Water Coalition

27 July 2014
Revised 29 September 2014

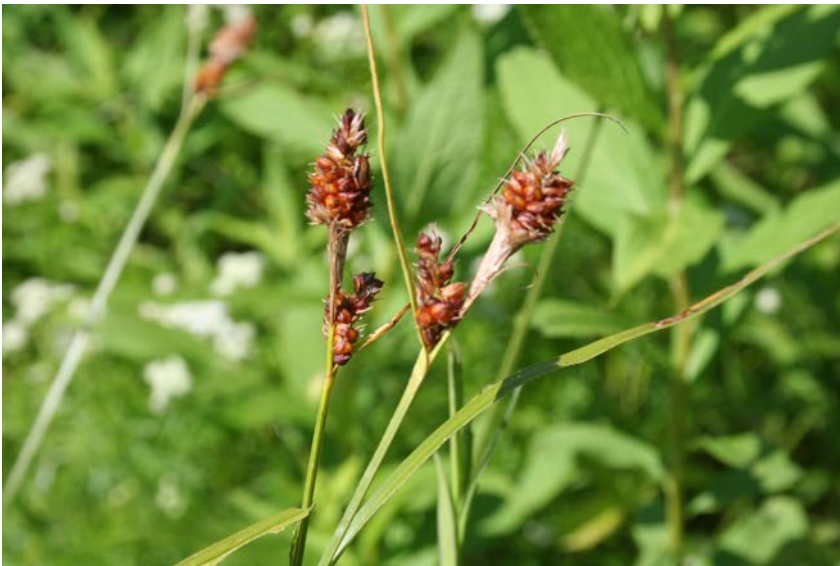
Bush's sedge (*Carex bushii*; S3 ; see photograph below). I found this sedge at two locations between Stoney Street and Lexington Avenue. There were small groups of culms (aerial stems) at these locations. At the first location, a south-facing slope in the northern edge of the ROW, Bush's sedge co-occurred with a native rose (*Rosa virginiana* or *R. carolina*); at the second location Bush's sedge was near the unidentified milkweed (see below) and various wetland plants in a (partially?) delineated wetland on the southern edge of the ROW.

Bush's sedge (*Carex bushii*; New York Natural Heritage Program rank S3) on the Algonquin Pipeline right-of-way west of Stoney Street, 9 July 2014.

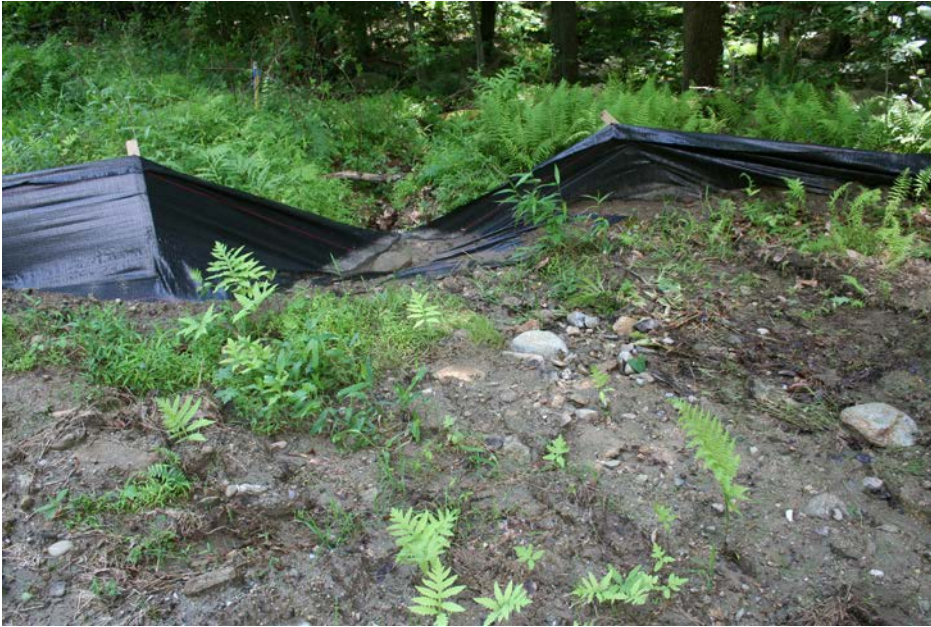
Poor siltation control practices on construction sites are widespread (Paterson 1994; Kiviat, personal observations). Prefabricated silt fencing was considered subject to technical deficiency, poor installation, and inadequate maintenance (Paterson 1994), and field measurements showed that silt fencing removed little of the fine sediment from stormwater leaving construction sites (Barrett et al. 1995, 1998). An existing filter fabric silt fence east of Stoney Street, evidently intended to prevent sediment from the equipment road on a steep slope escaping into a small stream draining north-to-south through Wetland A-34, on 9 July had a segment where sediment had overtopped the fence during a recent storm (see photo, below). This stream flows into Hunter Brook which flows into the New Croton Reservoir approximately 1.8 miles (map distance) SSW of Wetland A-34. This illustrates the risk that the proposed pipeline construction poses to the New York City reservoir system, as well as to wetland and stream habitats.

Filter-fabric silt fence overtopped by storm flow draining into Wetland A-34, photographed 9 July 2014. Photograph looking downhill from the pipeline right-of-way just east of Stoney Street.

AIM funds should be put into escrow for a full-time independent environmental monitor administered by, e.g., the town CACs or the New York City Department of Environmental Protection. This individual would monitor siltation control, equipment (to make sure it stays on the ROW), the appropriate procedures for salvaging and restoring native plants, and other environmental practices. It is not adequate for construction and restoration to be monitored only by the Applicant's consultants. There should also be compliance bonding to ensure remediation or restoration if damage occurs, and to ensure that permit conditions are met.
